DURABILITY AND BEHAVIOR OF PRESTRESSED CONCRETE BEAMS

Report 6

POSTTENSIONED CONCRETE BEAM
INVESTIGATION, SUPPLEMENTAL
LABORATORY TESTS OF BEAMS
EXPOSED FROM 1961 TO 1982

October 1984

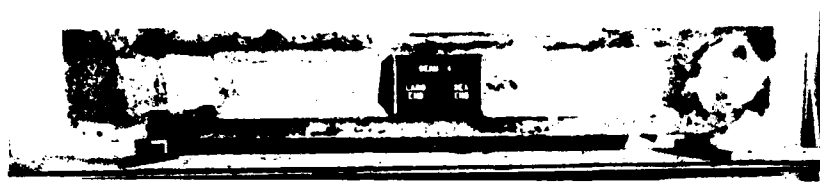
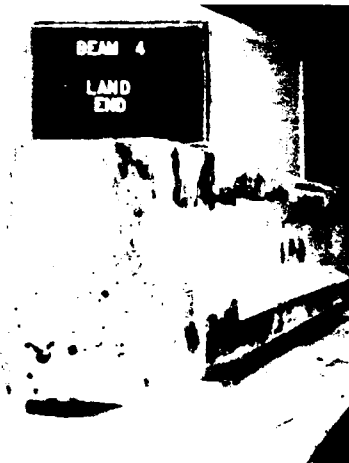
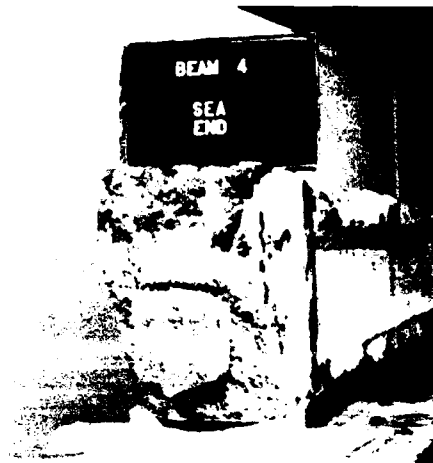
Figure 3. As-received and failure conditions of beam 4

17. The as-received condition of beam 4 is shown in Figure 3. Concrete had spalled on some edges exposing the conventional reinforcement to attack by seawater. Sixty percent of the conventional reinforcement was exposed on one top edge. Several small places on the other top edge and one bottom edge showed exposed reinforcement. The exposed reinforcement on the seaward end, bottom edge, was corroded completely through. All exposed reinforcement was heavily rusted and deteriorated. The lower half of the seaward end had spalled from the end of the beam, exposing part of the epoxy concrete end protective plug and end anchor. The plug covering the end anchorage was still in place over the end anchor. At the landward end, there was a 1/2-in.-wide by 1/2-in.-deep gap between the beam and the end cap. Otherwise, the landward end epoxy concrete cap was in good condition.

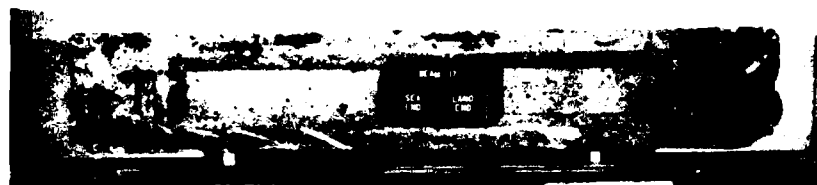
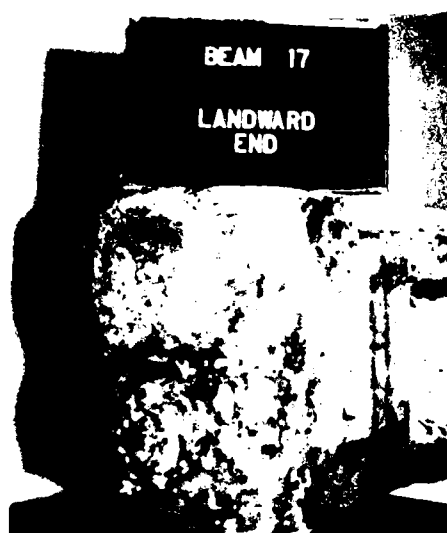
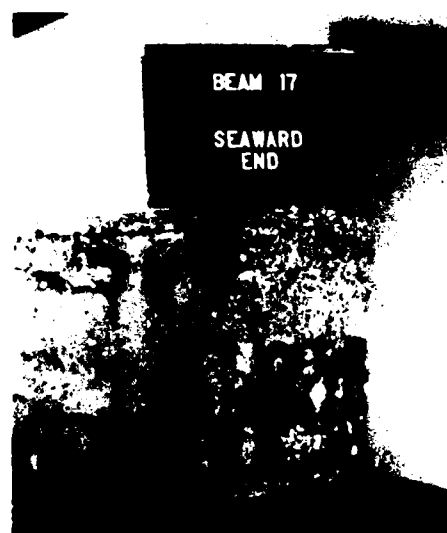
Figure 4. As-received and failure conditions of beam 17

23. The "as-received" condition of beam 17 is shown in Figure 4. The concrete was spalled away at the edges on much of the beam, exposing the conventional reinforcement. On one side of the beam, the top edge had reinforcement exposed the whole length of the beam proper. The bottom edge had exposed reinforcement in two small spots. The exposed reinforcement was badly deteriorated. The steel exposed on the bottom edge of the landward end had been completely corroded through its cross section. Both protective end caps were missing, exposing the end anchorages to seawater. The concrete along the edges had spalled, exposing conventional reinforcement on both edges of the landward end of the beam and on one edge of the seaward end.

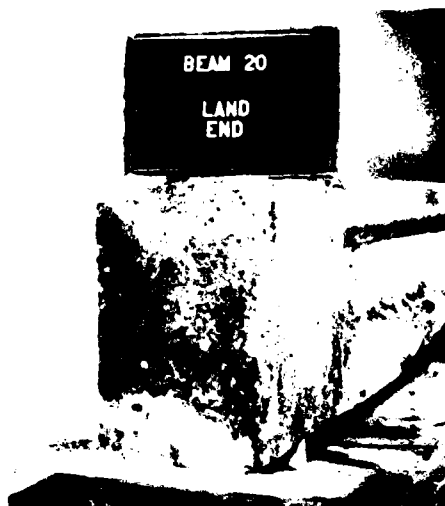
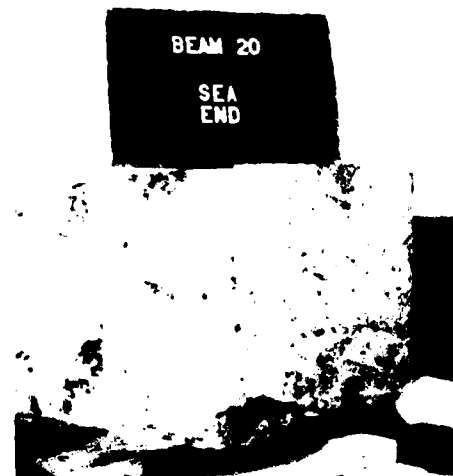
Figure 5. As-received and failure conditions of beam 20

30. The "as-received" condition of beam 20 is shown in Figure 5. Concrete was spalled away at the edges on much of the beam exposing some conventional reinforcement. On one top edge, the reinforcement was exposed along the total length. Both bottom edges had some exposed reinforcement. All exposed reinforcement was heavily corroded. Reinforcement in one area on the bottom edge had been completely corroded through its entire cross section. The landward protective end cap was in place and in generally good condition. This epoxy concrete end cap was anchored to the beam through the aid of reinforcing bars that protruded from the end of the beam into the cap. The end cap was separated from the beam proper by a 1/2-in. gap that was 1/2 in. deep (Photo 10). The reinforcement that held the end cap to the beam at this end of the beam was heavily covered with rust. There were two pieces of reinforcement that connected the cap to the beam. One piece was not reduced in cross section by the corrosion, but the other was reduced at the point where the 1/2-in. gap occurred, until the diameter of the bar was only 3/16 in. The seaward epoxy concrete end cap was also in place, but 4 in. of the bottom of the end cap had spalled away. This end cap was also partially separated from the beam by a 1/2-in. gap that was 4 to 8 in. deep (Photo 11). This end cap did not have reinforcing bars anchoring the cap to the beam.

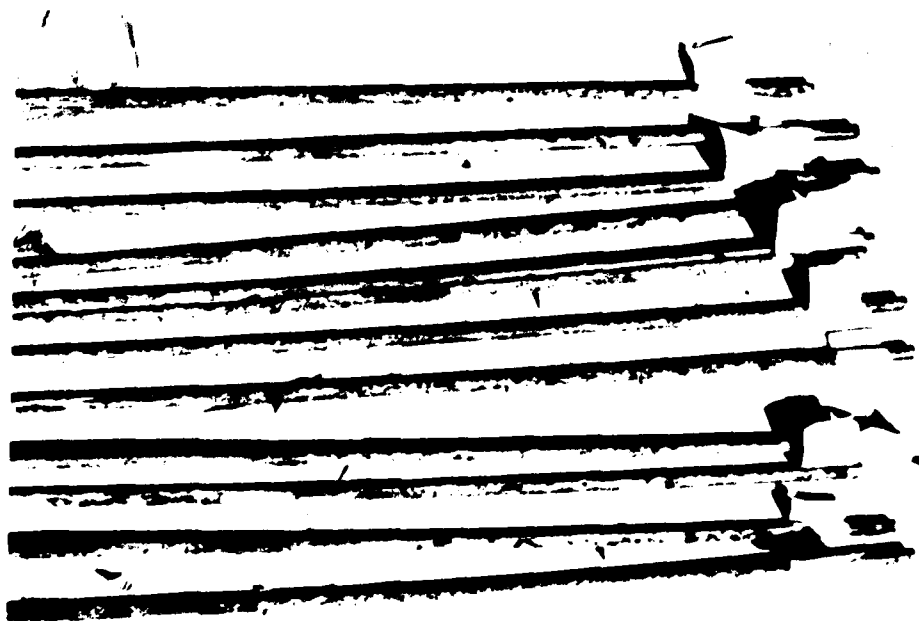
28. Most of the 12 posttensioning wires were lightly to moderately corroded along all of the seaward half and on 65 percent of the landward half. The heaviest rusting occurred within 15 in. of the landward end of the wires (Photo 8). All 12 wires were described as heavily rusted on the outermost 15 in. of their landward end. Two wires were described as heavily rusted from 3 in. to about 15 in. along their seaward end. Streaks of rust from 3 to 15 in. long where wires appeared to have been touching each other were found on 6 of

Photo 8. Twelve wires of beam 17 showing heavy rusting on
landward ends

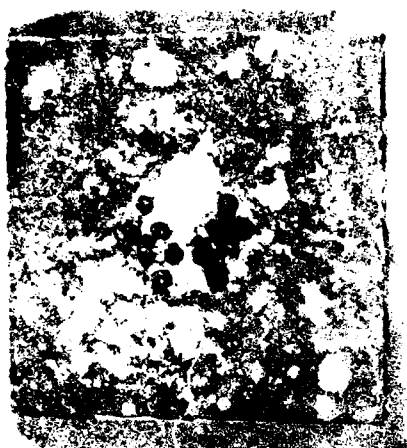
29. The surface of the outside face of the seaward anchorage was heavily corroded (Photo 9). Portions of this anchor were deteriorated to the point of metal flaking from the rest of the anchor. The inside face of the seaward anchorage was similar to that of the landward anchorage, with heavy cover of rust but no severe loss of metal area.

Photo 9. Seaward anchorage of beam 17 showing heavy corrosion

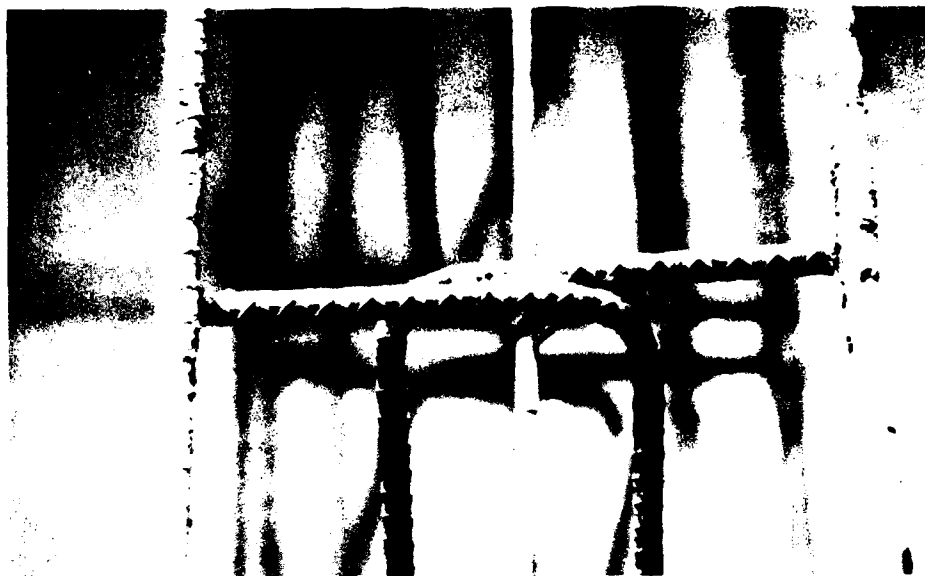
43. The reinforcing stirrups of beams 4, 17, and 20 all experienced some degree of corrosion. Basically the stirrups were only lightly corroded, with rust covering less than 10 percent of the surface area. The magnitude of the corrosion on the stirrups was no greater than that observed on the stirrups in the 1975 autopsy. Most of the corrosion was light surface rust, although beam 20 did have some areas that showed signs of deterioration. The corrosion was concentrated on the stirrups from the weld points to the longitudinal reinforcement and where the stirrups themselves were attached together (Photos 19-20). An attempt was made to correlate areas of rusted stirrups with any staining of the surface of the beam, and the result was that no rust stains on the surface of the concrete beam could be associated with any incidence of stirrup corrosion. Since most of the corrosion appeared at weld points, the process of welding the bars together may have changed the properties of the steel such that these areas were more susceptible to corrosion than areas that had not been heat-treated. Some spot corrosion was observed on the vertical sections of the stirrups (Photo 22), but this was only very light surface corrosion. The outsides of the conduits containing the posttensioning wires were also only lightly rusted. These observations indicate that, even though the concrete cover over the stirrups and the tendons was thin, the ingress of water, oxygen, and chlorine ion at the web section of the beam did not cause heavy damage to the stirrup reinforcement.

Photo 19. Stirrup of beam 4 showing rust around weld point

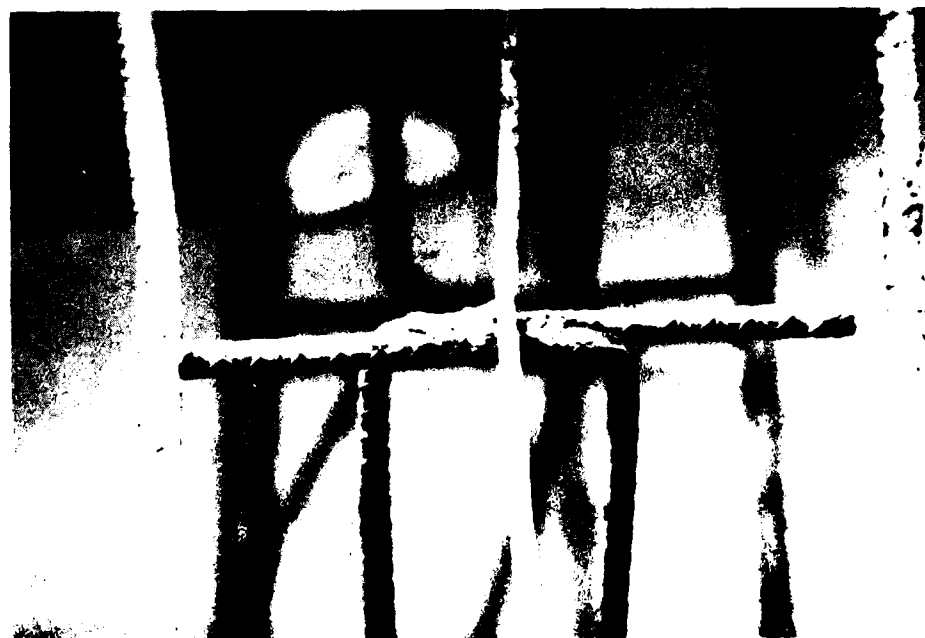
Photo 20. Stirrup of beam 17 showing rust around weld point

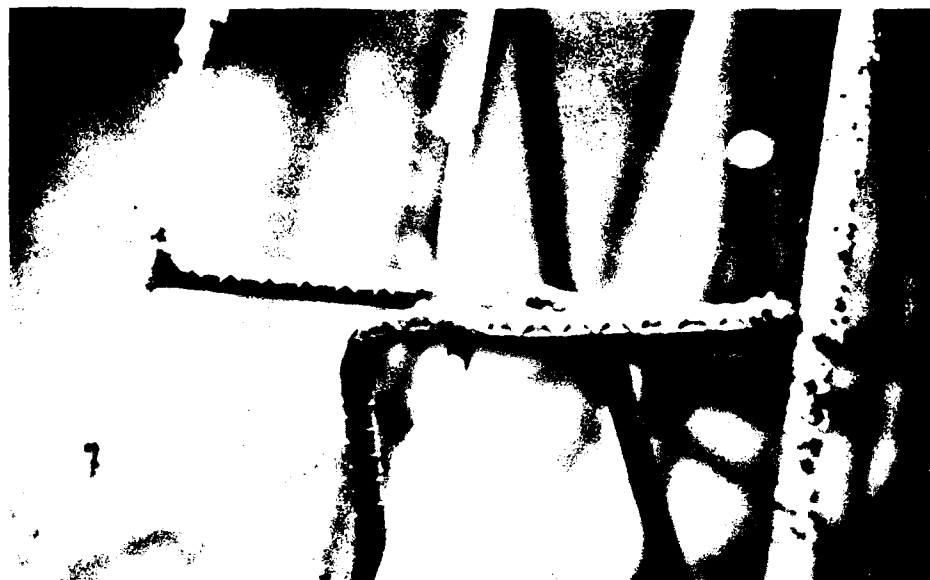
Photo 21. Stirrup of beam 20 showing rust around weld point

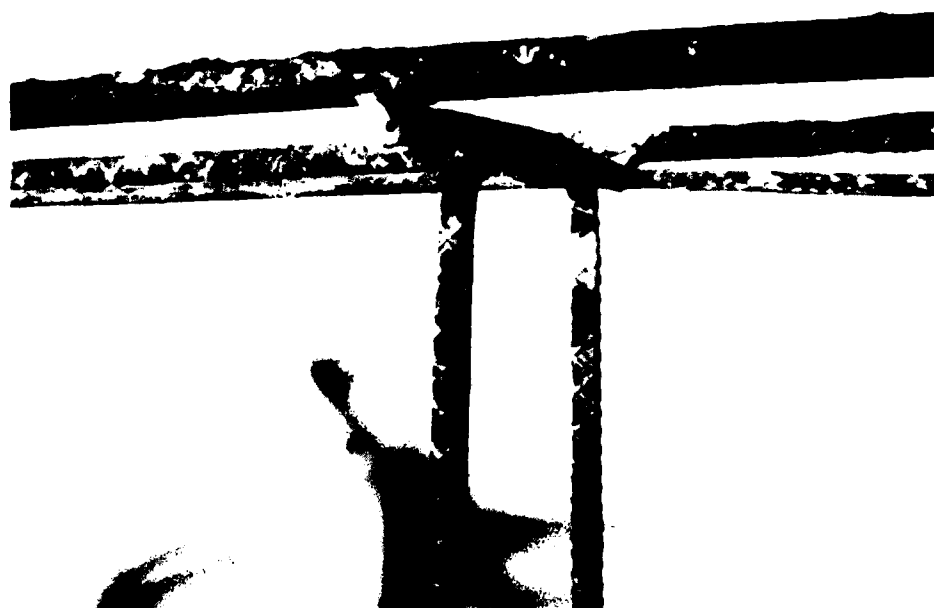
Photo 22. Stirrup of beam 4 showing spot of light surface rust
